Navajo Abandoned Uranium Mine

Site Screen Report

Mesa IV 1/2 Mine and Simpson 181 Site

March 2010

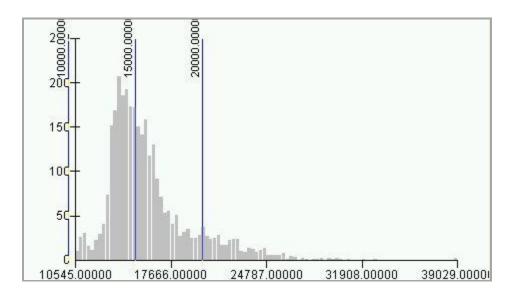
The following chart and statistics were generated by ESRI ArcGIS 9.3.1, and show the general distribution of the site gamma radiation measurements. The horizontal X axis represents the gamma radiation reading levels in cpm (lowest levels to the left). The vertical Y axis represents the frequency of each gamma radiation level.

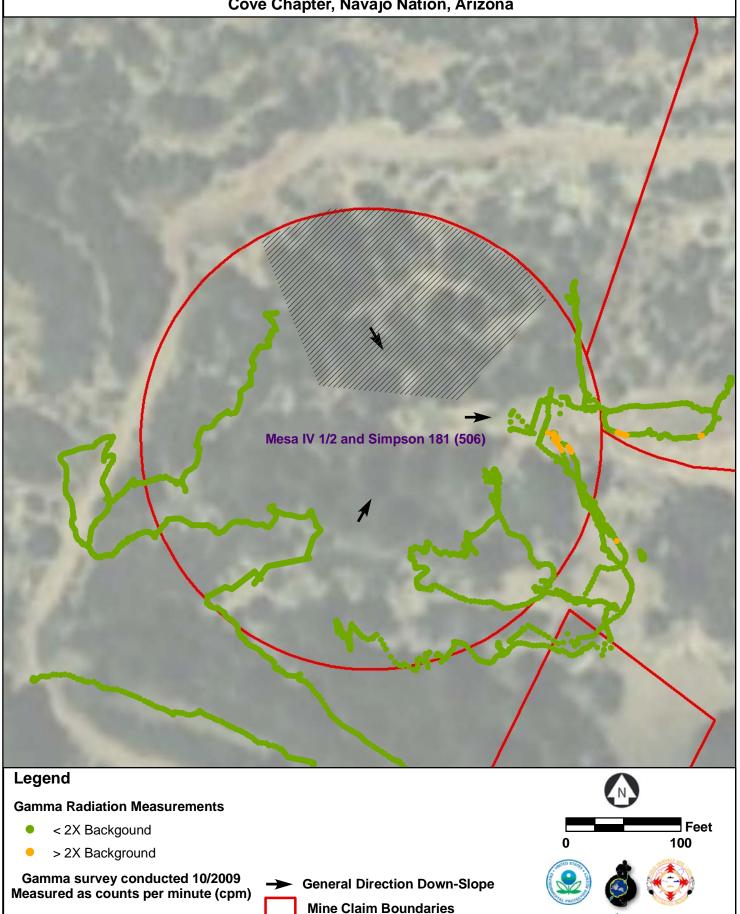
Figure 1 - Gamma Radiation Measurements, Above Two Times Background
Mesa IV 1/2 and Simpson 181 (506)
Cove Chapter, Navajo Nation, Arizona

A total of 3,121 gamma radiation measurements were collected from the mine site, ranging from 10,545 cpm to 39,029 cpm. Measurements in the vicinity of the concrete pad were found at levels in up to 17,000 cpm, and in the drainage coming off the concrete pad at approximately 30,000 cpm. The measurements are represented in Figures 1 and 2.
